WARTIME REPORT

AN INVESTIGATION OF A THERMAL ICE-PREVENTION SYSTEM
FOR A C-46 CARGO AIRPLANE

III - DESCRIPTION OF THERMAL ICE-PREVENTION EQUIPMENT
FOR WINGS, EMPENNAGE, AND WINDSHIELD

By Alun R. Jones and Ray J. Spies, Jr.

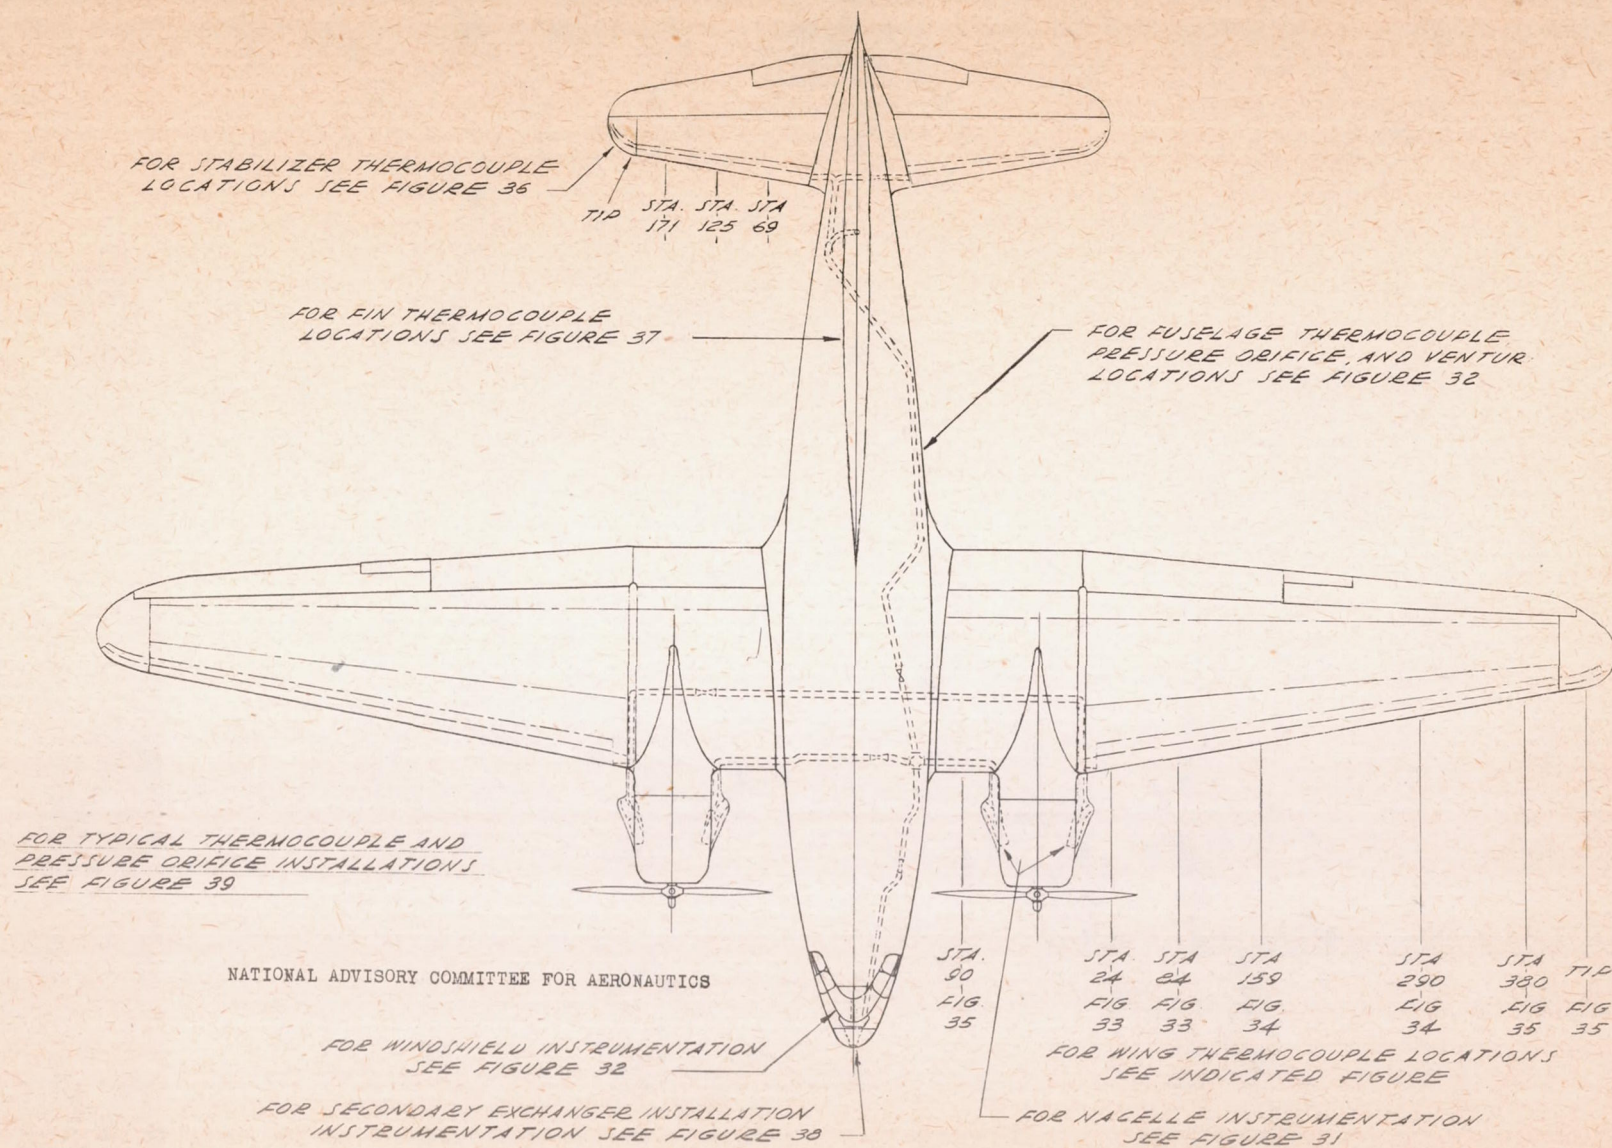
FIGURE 30. - INDEX TO THERMOCOUPLE AND PRESSURE-ORIFICE LOCATIONS ON C-46 AIRPLANE.

An index to the pressure-orifice and thermocouple locations for the entire thermal ice-prevention system is shown in figure 30, and the specific locations are given in figures 31 to 38. The dash numbers following the thermocouple and pressure-orifice designations in figures 31 to 38 indicate the type of mounting as detailed in figure 39. The pressure-orifice locations, for the most part, were confined to the venturi meters, although a few orifices were located in the air inlets of the left-nacelle heat exchangers, in the exhaust-gas stack of the left outboard exchanger, and in the secondary-exchanger windshield installation. The single pressure orifice located in the exhaust stack immediately forward of the left outboard exchanger (fig. 31) was connected to a manifold-pressure gage. All of the remaining pressures, including reference total and static pressures from a pitot-static head located beneath the airplane near the nose, were connected to a glass-tube alcohol manometer shown in figure 40.

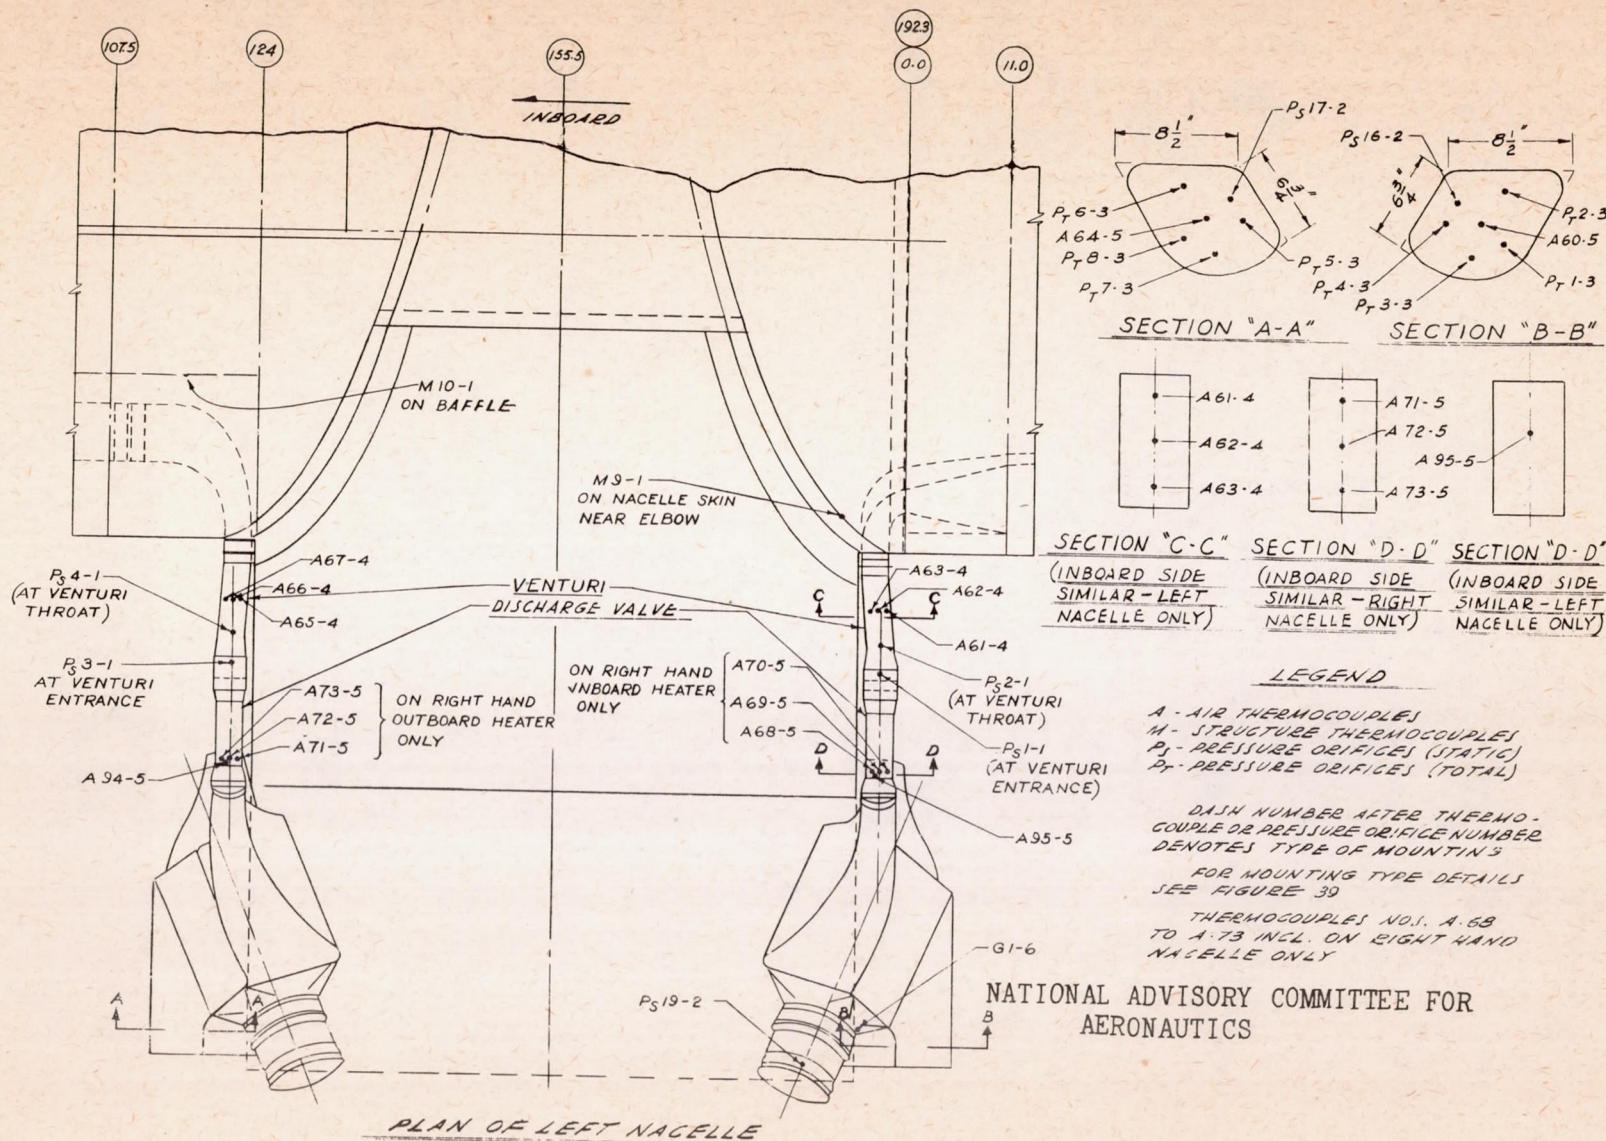
FIGURE 31 - THERMOCOUPLE AND PRESSURE-ORIFICE LOCATIONS FOR
HEAT-EXCHANGER INSTALLATION IN LEFT NACELLE
OF C-46 AIRPLANE.

All of the thermocouples were of iron-constantan wire with the exception of one exhaust-gas chromel-alumel thermocouple (designated G1, fig. 31) located immediately forward of the left outboard heat exchanger. The iron-constantan thermocouples (about 200 in number) were connected to a switching arrangement which provides manual or automatic thermocouple selection. When the unit is operated manually, the leads from the switching assembly are connected to a temperature-indicating instrument and the operator selects and observes the temperature of any one of the thermocouples. For automatic operation, the switching assembly is driven by a small electric motor and the leads are connected to a recording galvanometer. The temperatures are recorded as deflections on a 2.4-inch-wide roll of photographic film. The switching unit consists of nine banks of 24 thermocouple points each, and automatic operation is obtainable as follows: (1) Record the 24 points of any one bank and then stop; (2) record any one bank continuously; (3) record all nine banks in order and then stop; and (4) record all nine banks in order continuously. The temperature-selecting and -recording unit is shown in figure 41. The calibrating panel shown beside the temperature recorder is used to impress a series of constant known voltages on the recorder film for calibration purposes. The chromel-alumel thermocouple was provided with

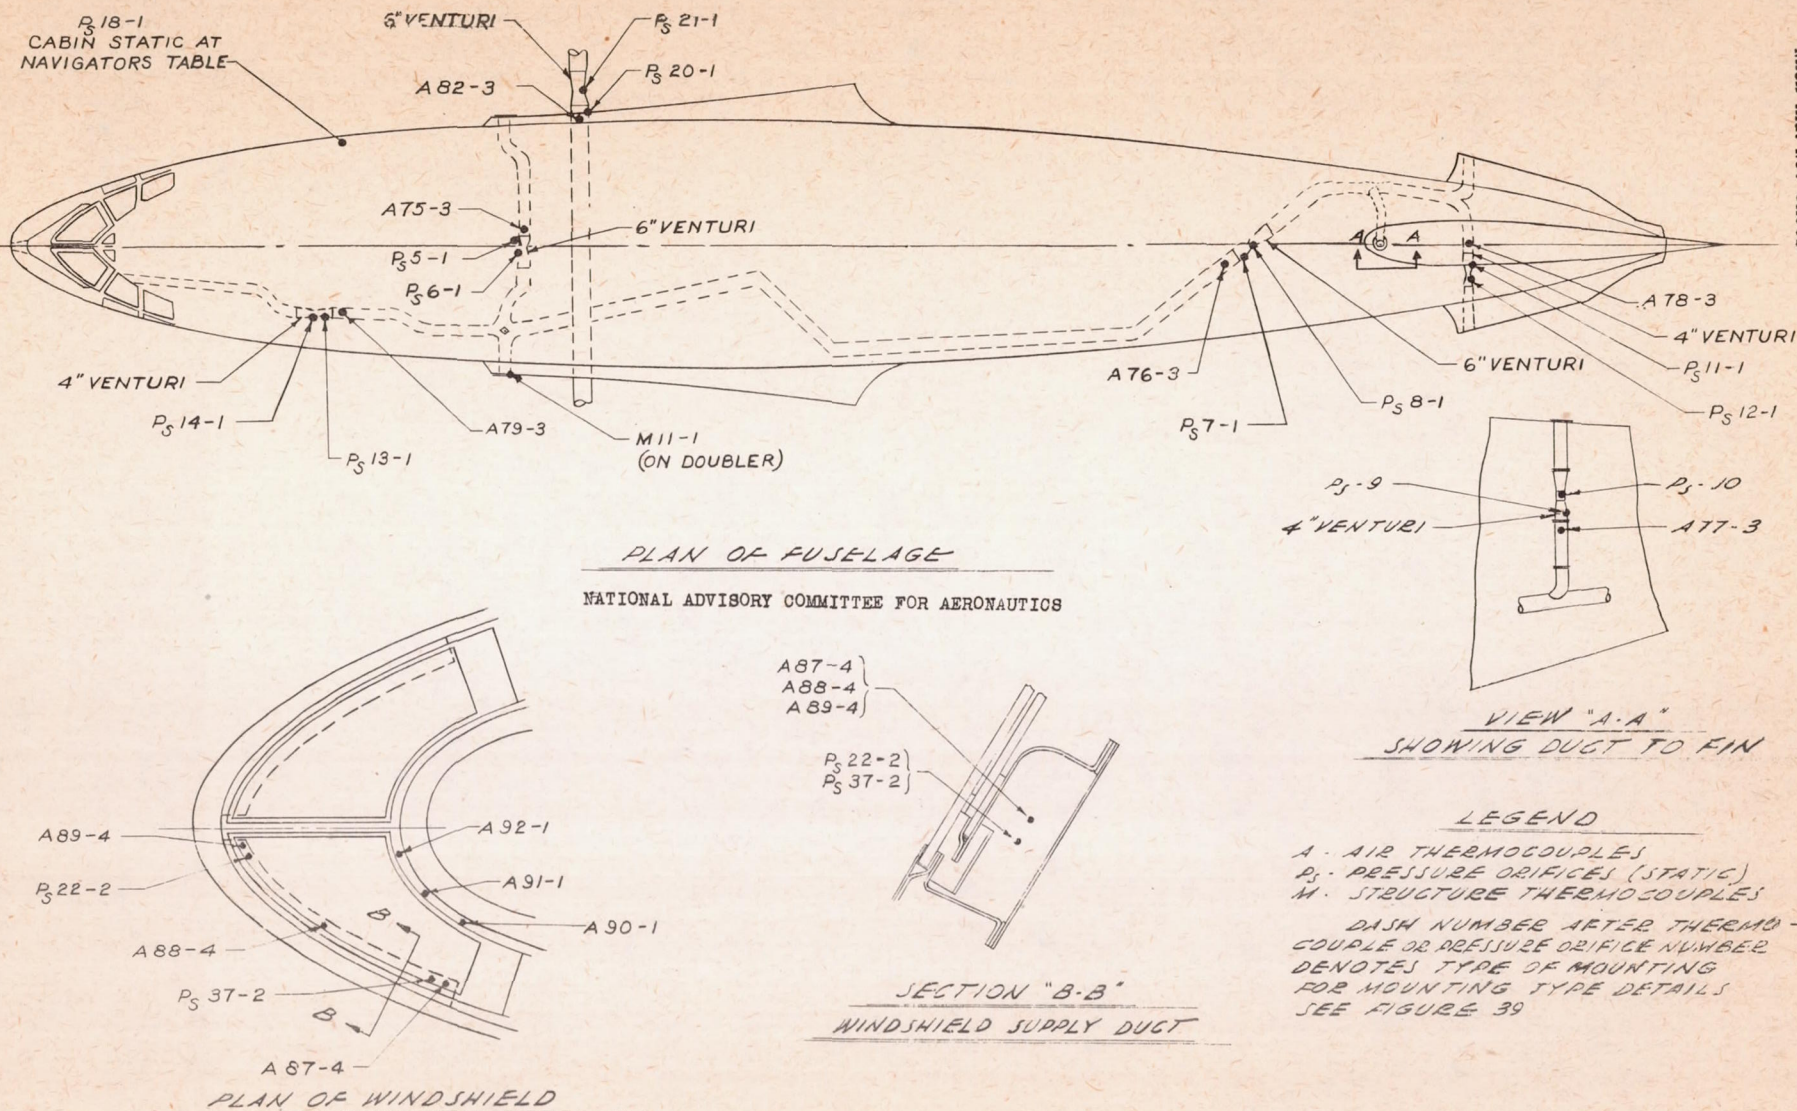
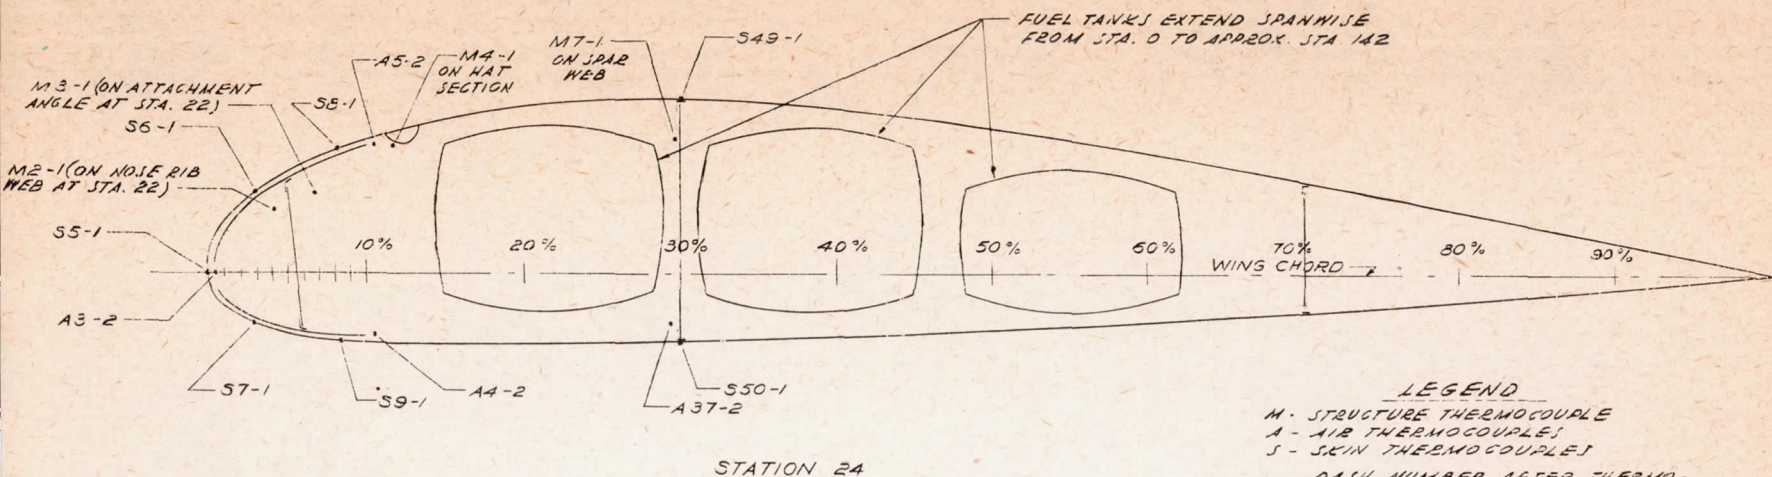
FIGURE 32.- THERMOCOUPLE AND PRESSURE-ORIFICE LOCATIONS FOR FUSELAGE DUCTS AND WINDSHIELD OF C-46 AIRPLANE.

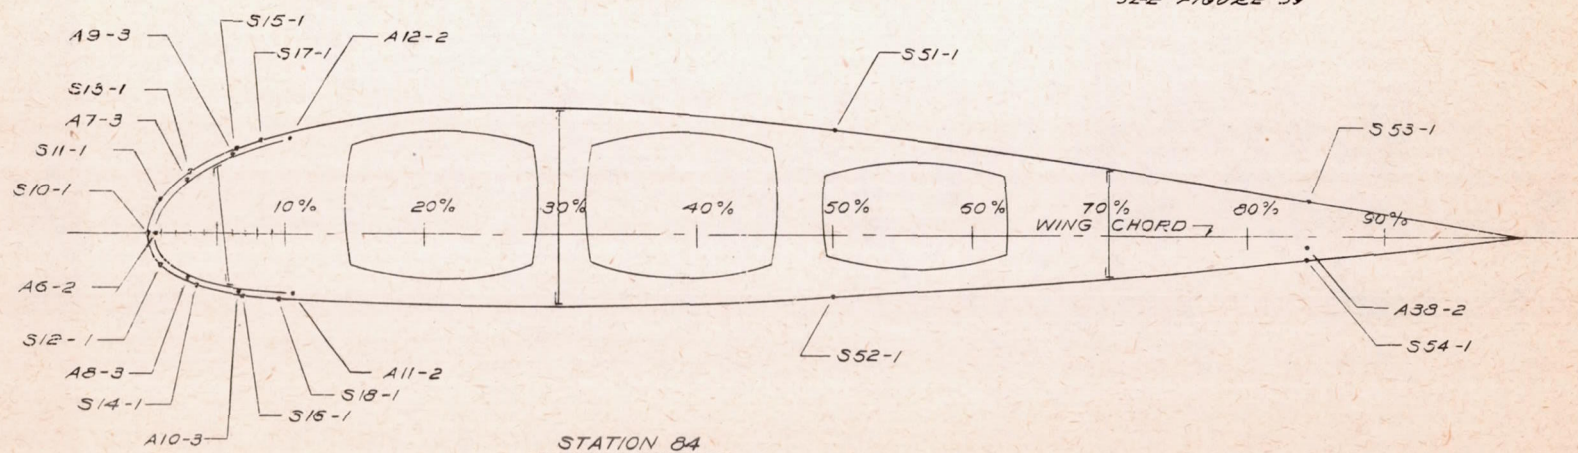
FIGURE 33.- THERMOCOUPLE LOCATIONS FOR WING OUTER PANEL - STATIONS 24 AND 84 - C-46 AIRPLANE.

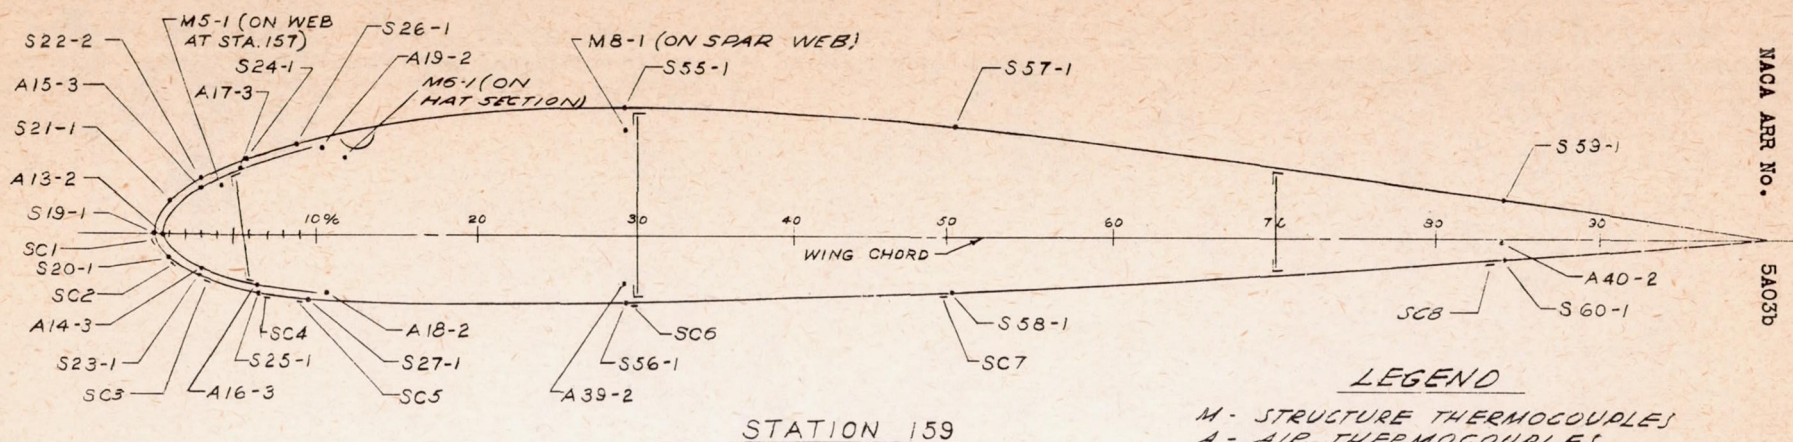
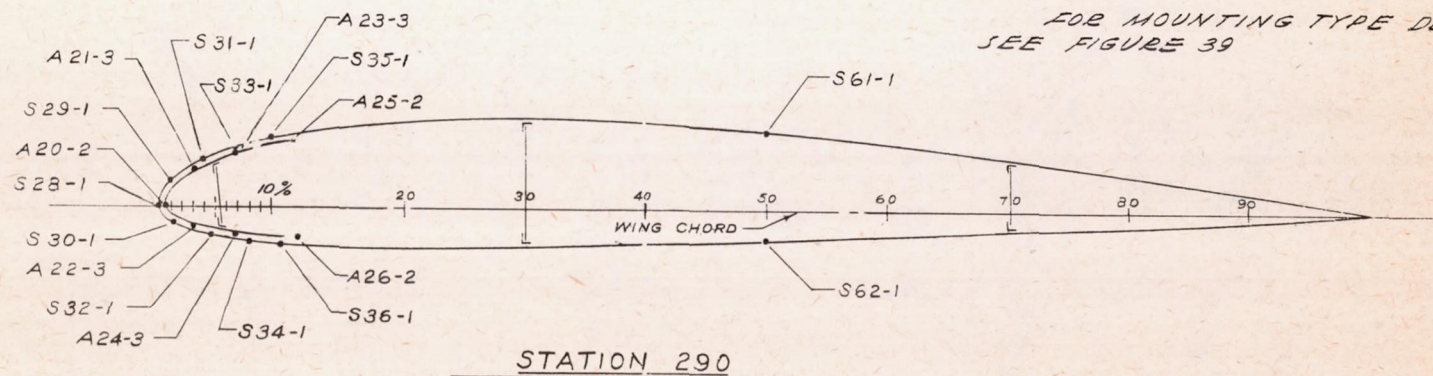
FIGURE 34. THERMOCOUPLE LOCATIONS FOR WING OUTER
 PANEL - STATIONS 159 AND 290 - C-46 AIRPLANE

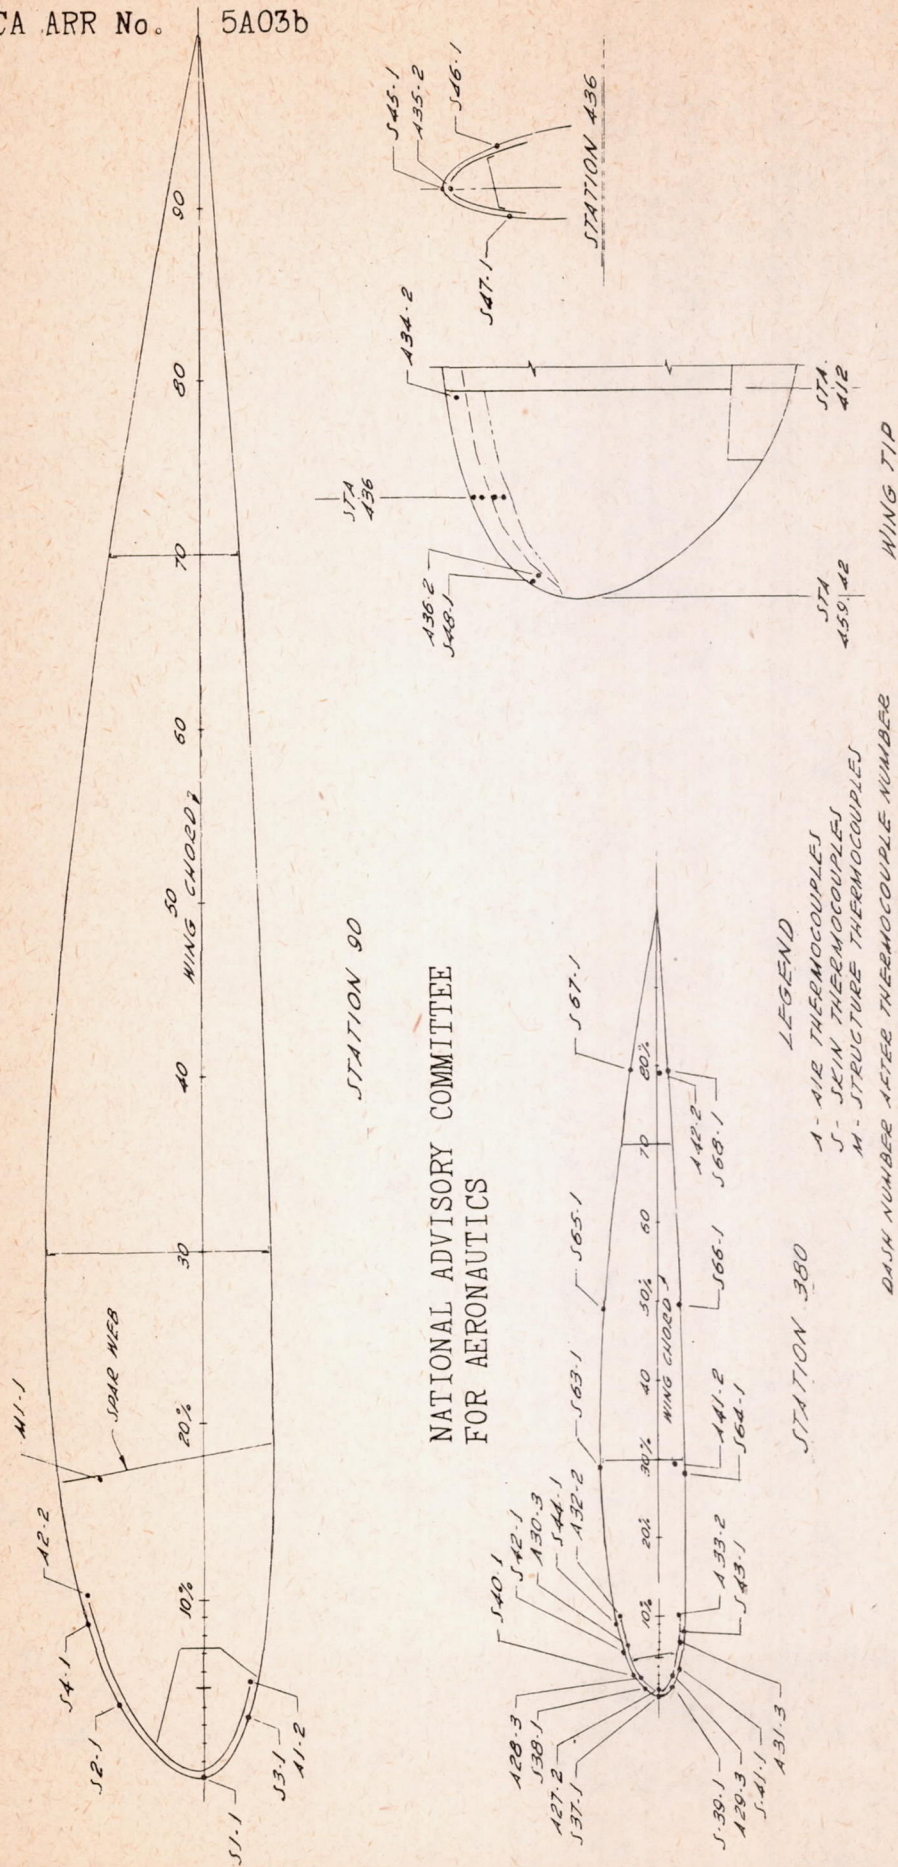
FIGURE 35-THERMOCOUPLE LOCATIONS FOR WING OUTER PANEL STATION 380, WING TIP, AND INBOARD PANEL STATION 90 - G46 AIRPLANE

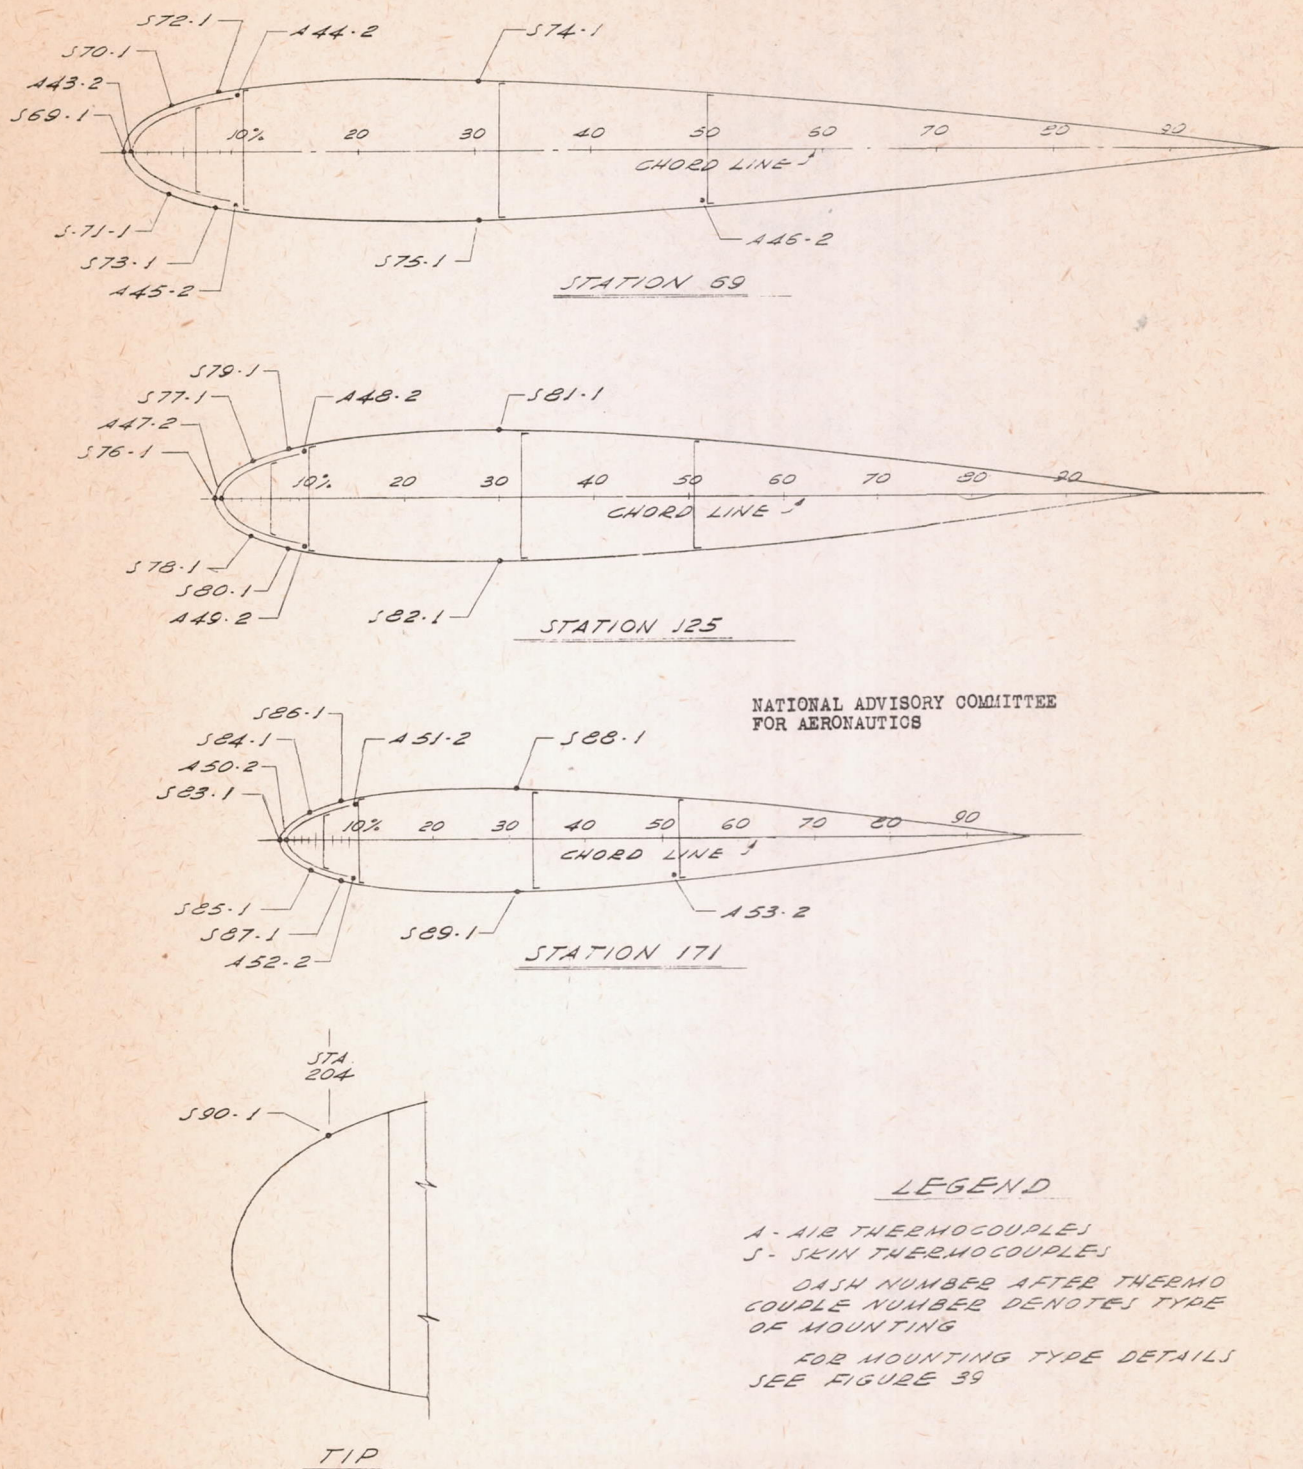
FIGURE 36 - THERMOCOUPLE LOCATIONS FOR
STABILIZER - C-46 AIRPLANE

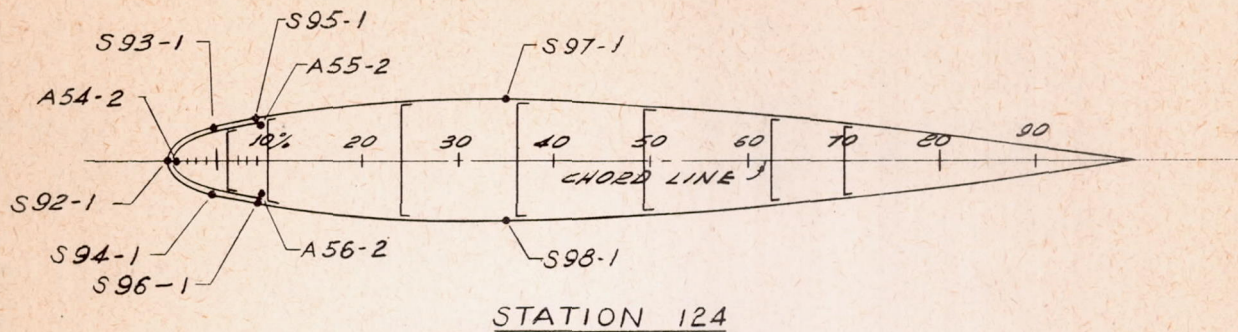
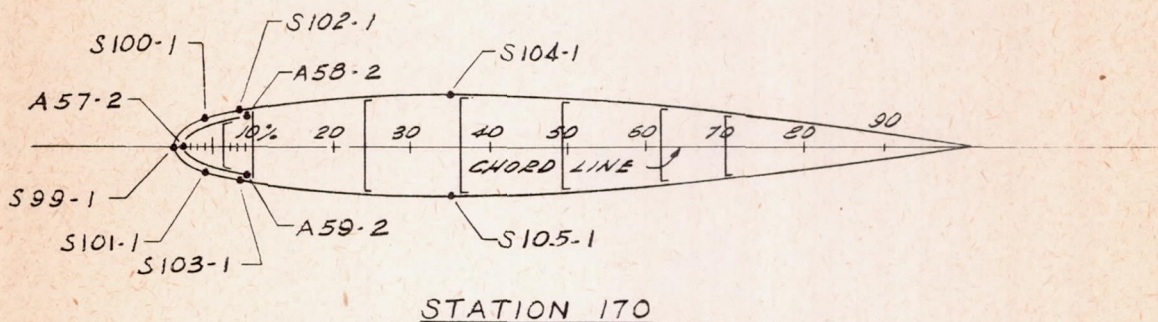
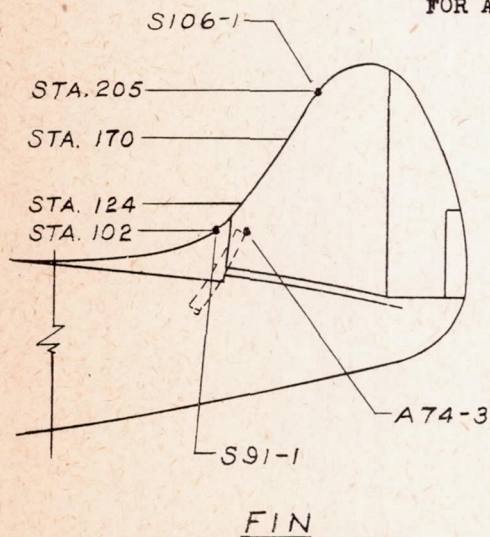
FIGURE 37 - THERMOCOUPLE LOCATIONS FOR
FIN - C-46 AIRPLANE

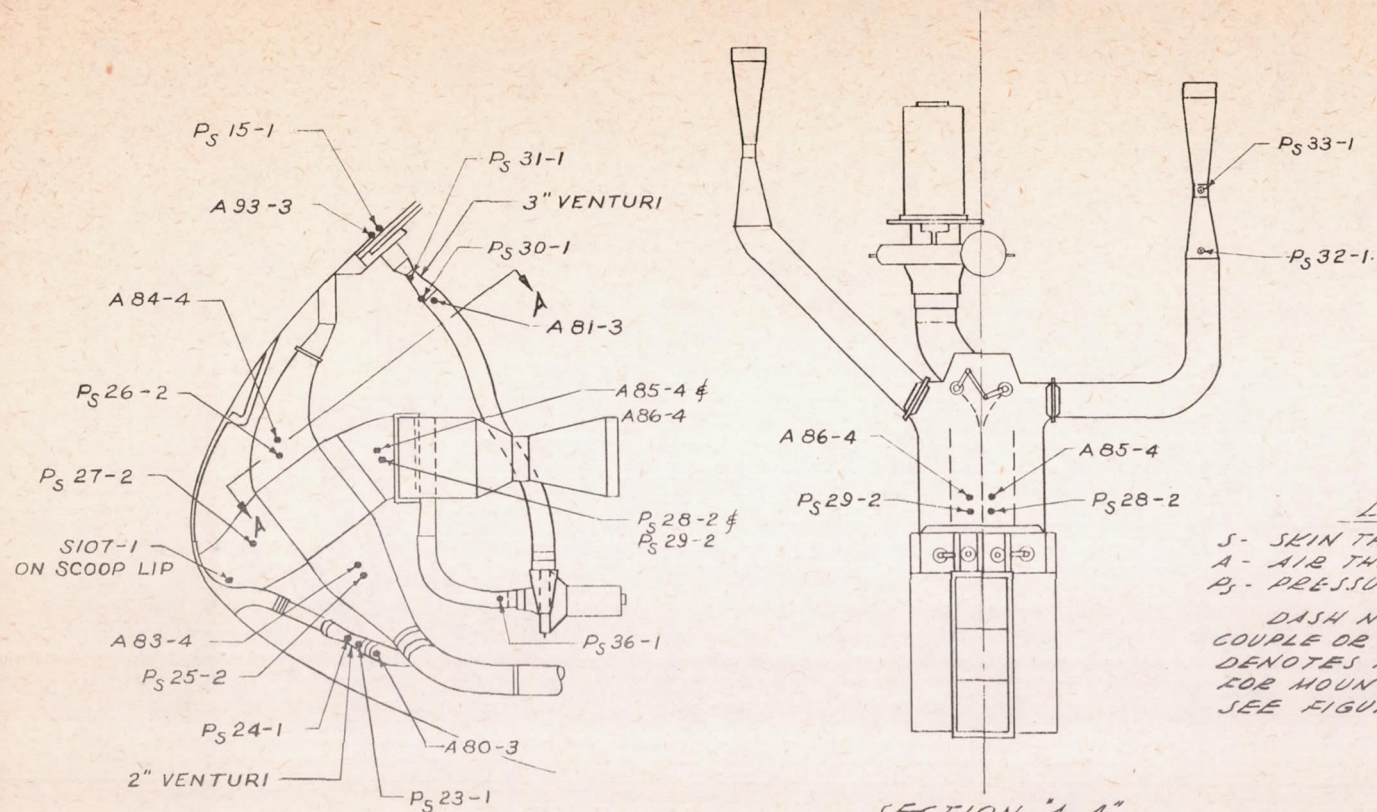
FIGURE 38- THERMOCOUPLE AND PRESSURE-ORIFICE LOCATIONS
FOR SECONDARY HEAT-EXCHANGER INSTALLATION
IN NOSE OF C-46 AIRPLANE

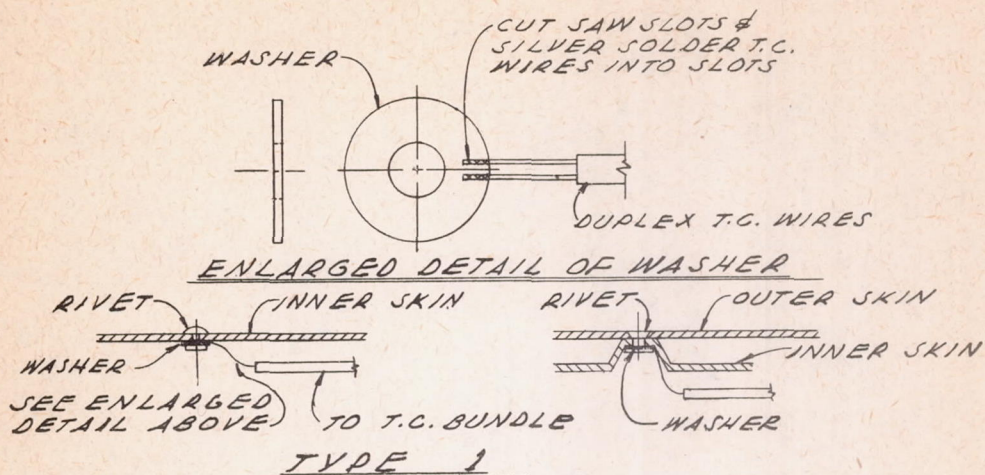
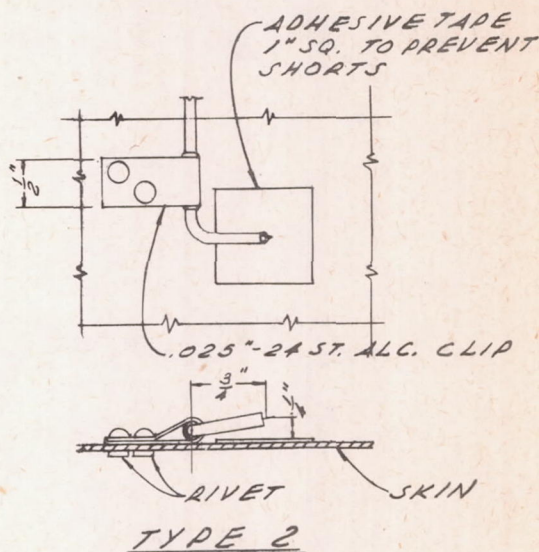
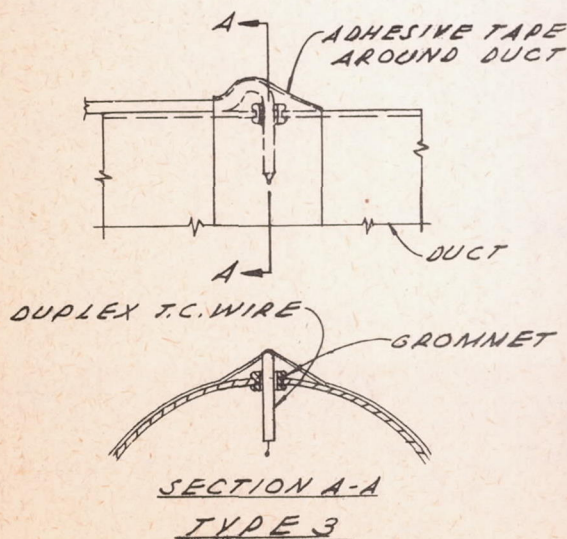
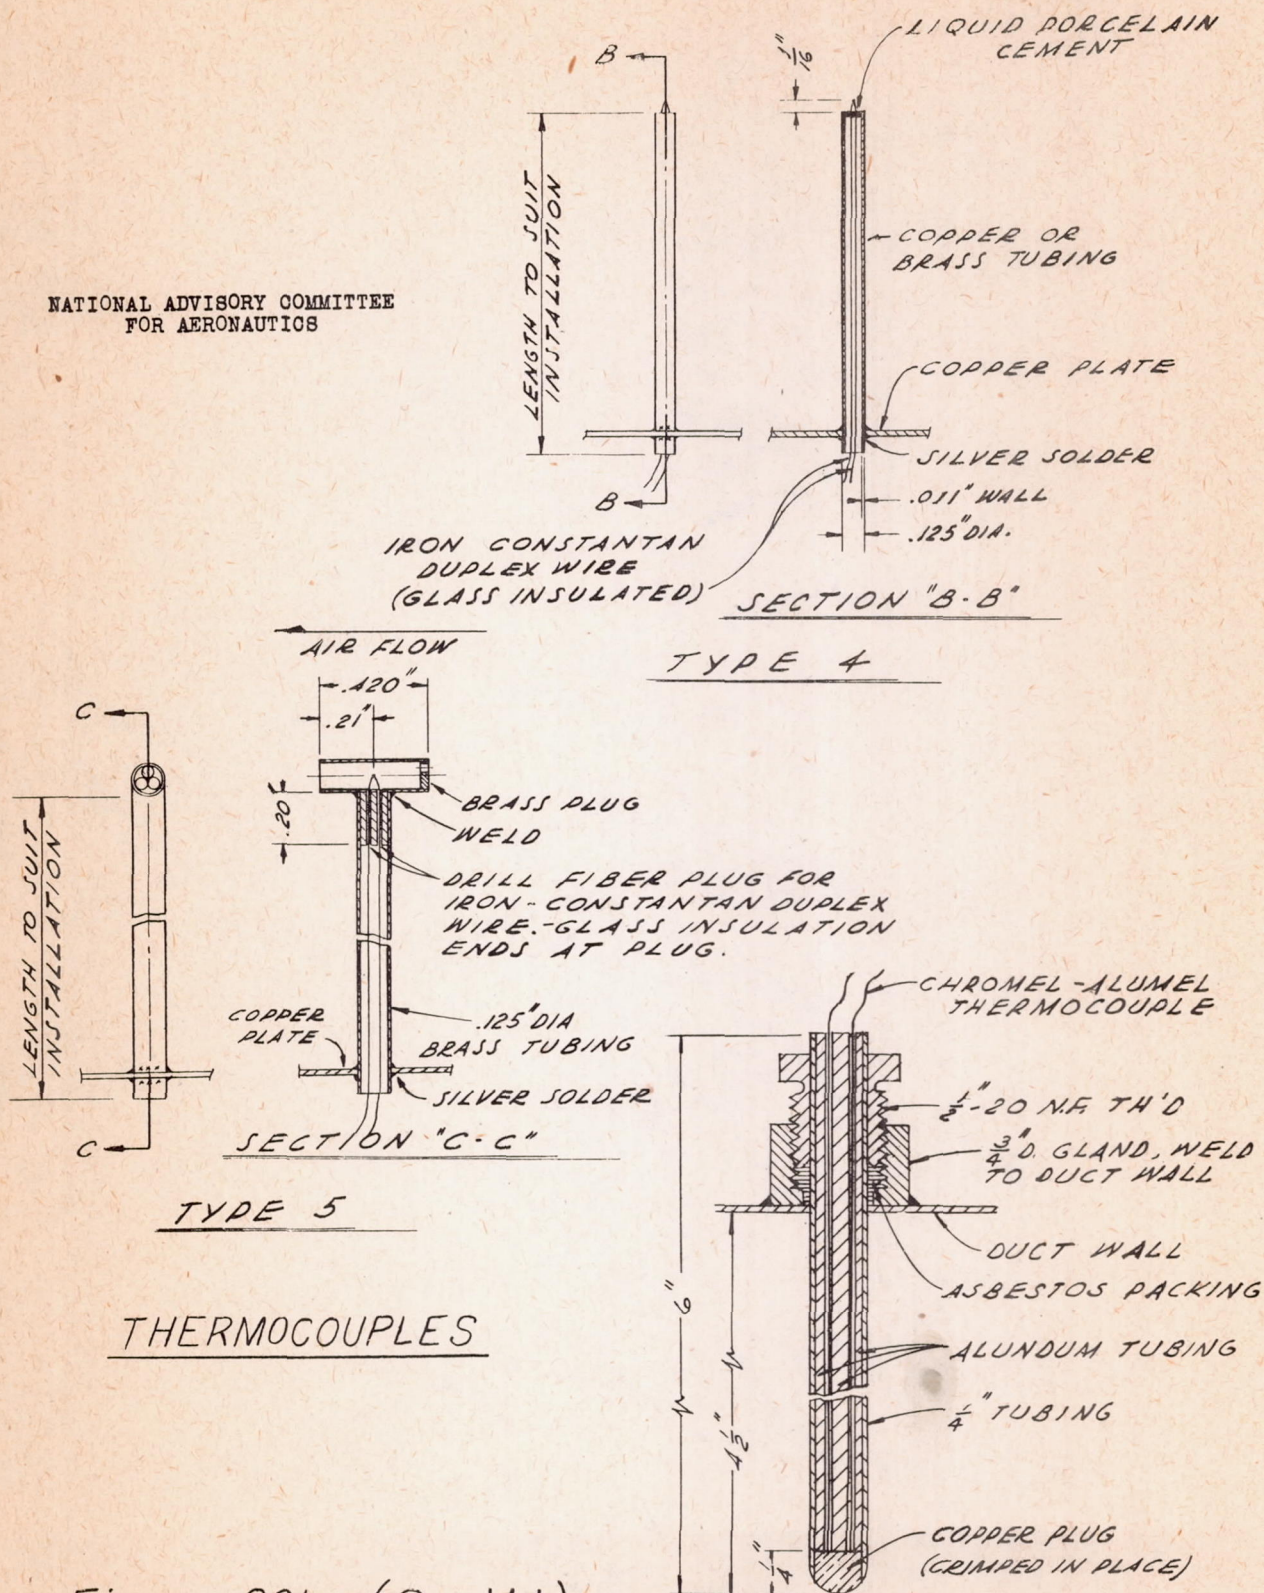
Figure 39(a to c).-
Types of
thermocouple and
pressure orifice
installations used
to determine per-
formance of ice-
prevention equip-
ment of the
C-46 airplane.

The accuracy of the data obtained from the thermocouple installation used to measure skin temperatures (type 1, fig. 39) has been difficult to establish. In order to compare the data from this type of thermocouple with a more delicate but probably more accurate type of installation, eight special thermocouples, designated as surface thermocouples, were installed at wing outer-panel station 159 at the locations shown in figure 34. The surface-type thermocouples were made from 0.005-inch-diameter manganin and constantan wires which were butt-welded together and then rolled to a flat strip approximately 0.002 inch thick. The thin strip was then placed on the outer surface of the airfoil skin with the junction within 1/4 inch of the washer (type 1) installation. Because the eight surface thermocouples were manganin-constantan, they could not be added to the iron-constantan recorder circuit and therefore they were connected to a switch with a separate set of lead wires.

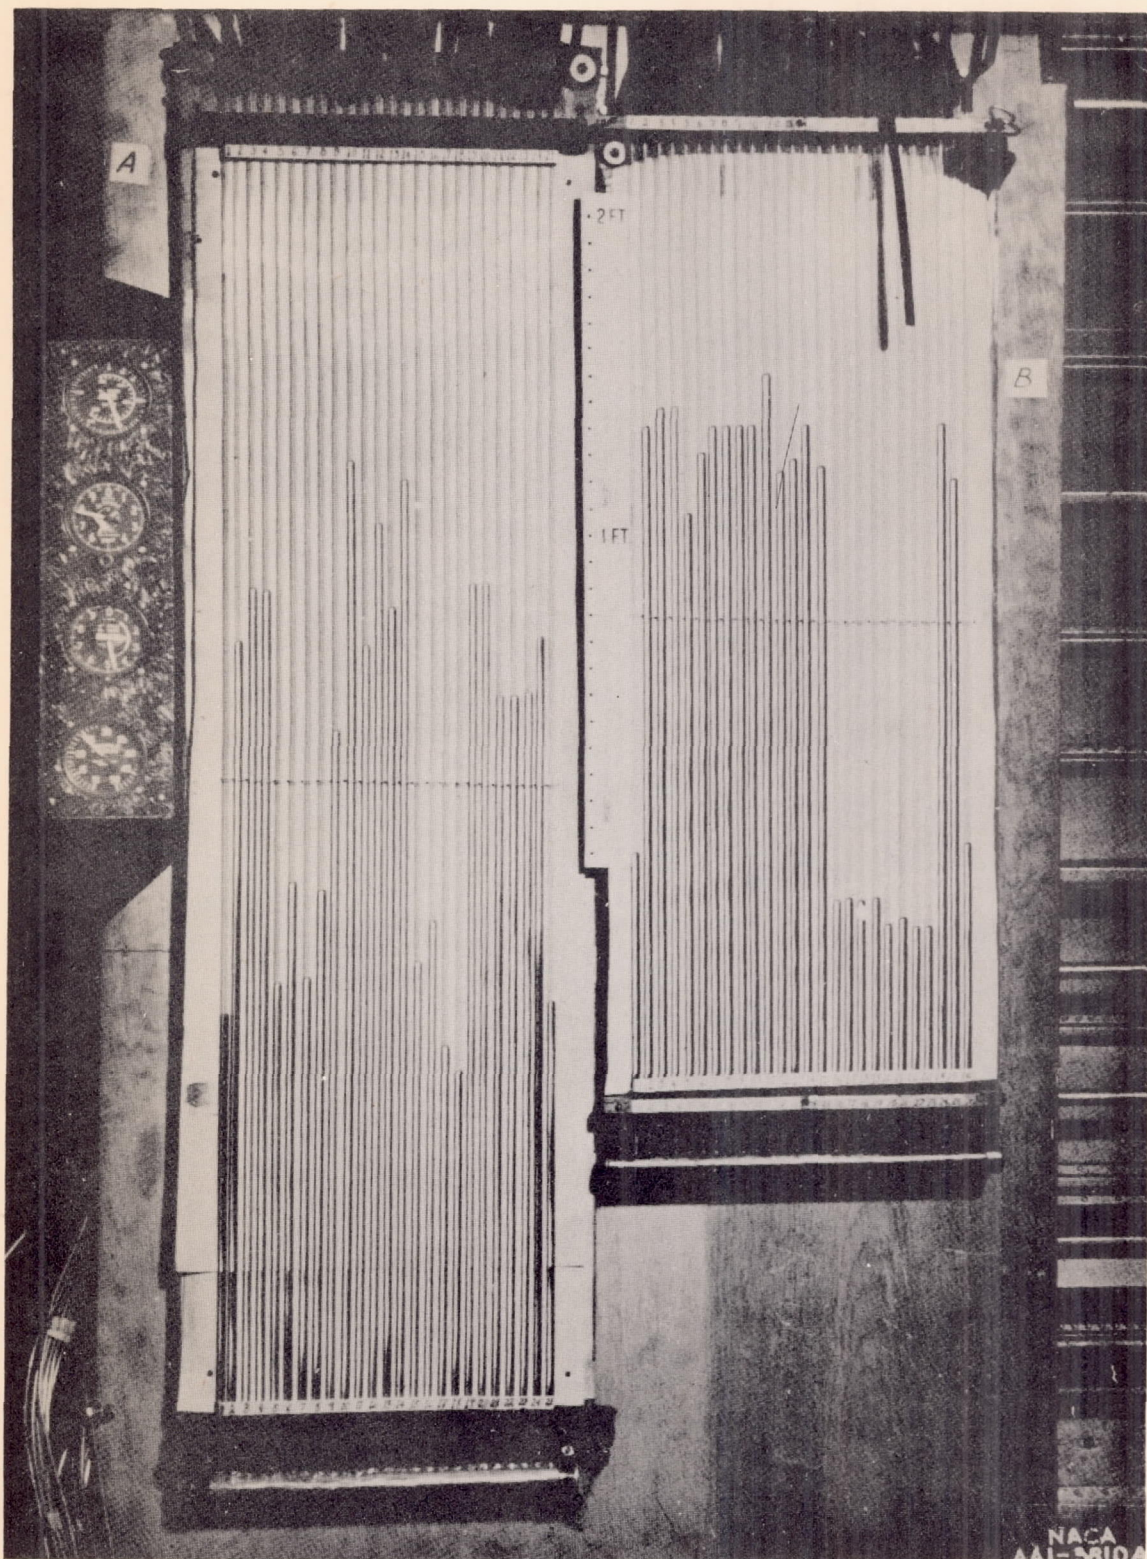
Figure 40.- Alcohol manometer installed in cabin of C-46 airplane for indicating pressure differentials in performance tests of thermal ice-prevention equipment.

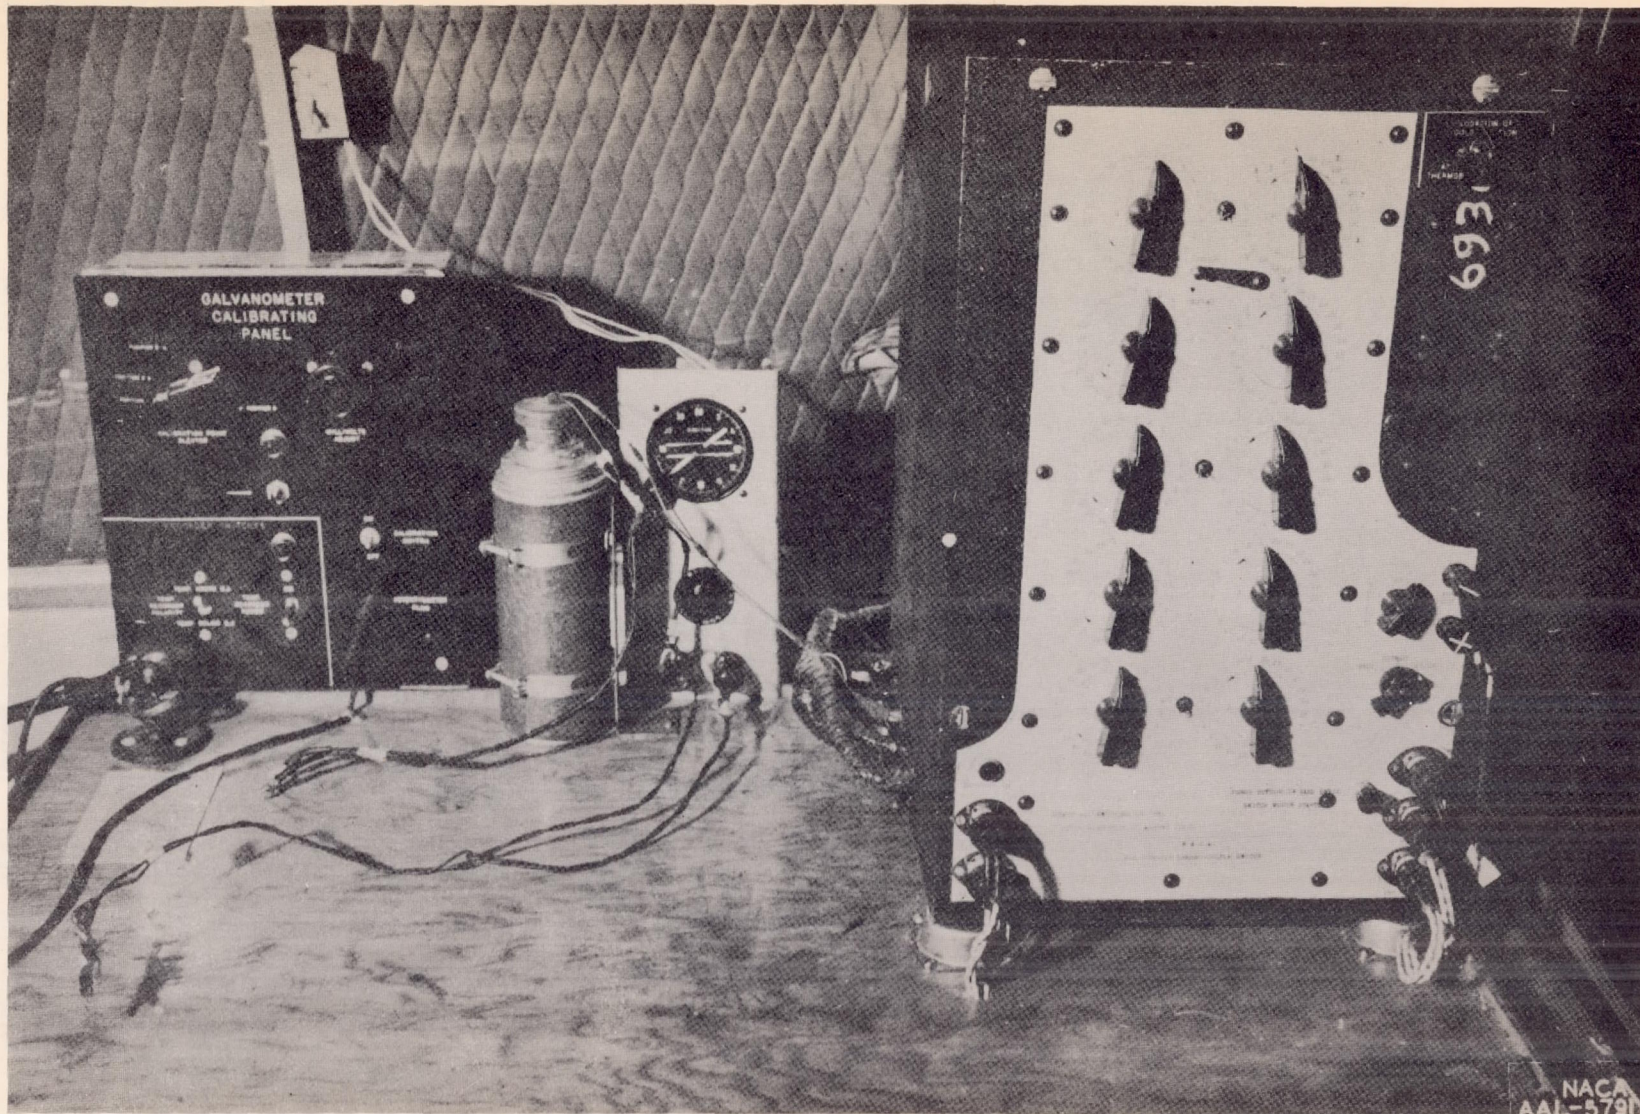
Fig. 41

Figure 41.- Thermocouple selecting unit and recorder installed in C-46 airplane for performance tests of thermal ice-prevention equipment.
